## GU OLD CASE DESIGN

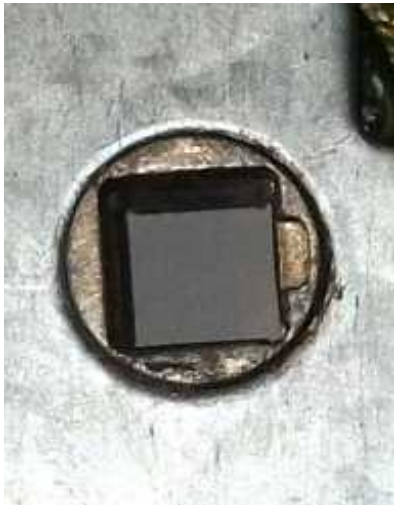
LH Side

In the rare even of having to open one of these by other means If locked the cam follower can be accessed either side **5mm up and 7mm back** (white arrow) from the top centre of the profile.

To release the mechanism another slot is available at **20mm up and 15mm forward**, (green arrow) however, this might be outside the handle profile and it will be necessary to angle drill.

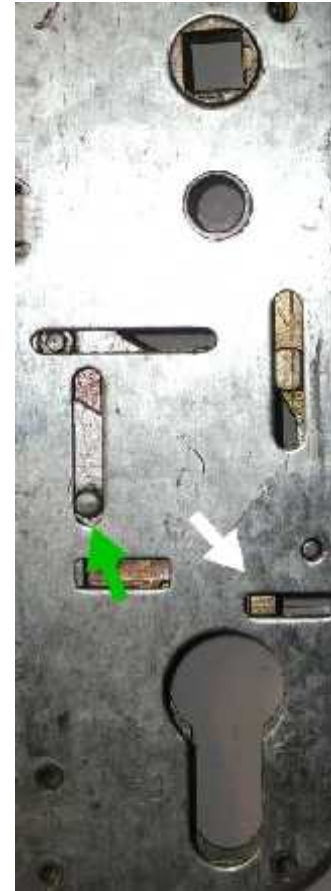
This case is easily be identified by the markings on the spindle follower.
